# ***Loring Air Force Base Tank Farm***

## **SOIL RX PERFORMANCE TRIAL MINIMIZING THE ENVIRONMENTAL IMPACT AND REMEDIATING FUEL CONTAMINATED SOILS**

# *Loring Air Force Base Tank Farm Soil Rx Remediation Trial*

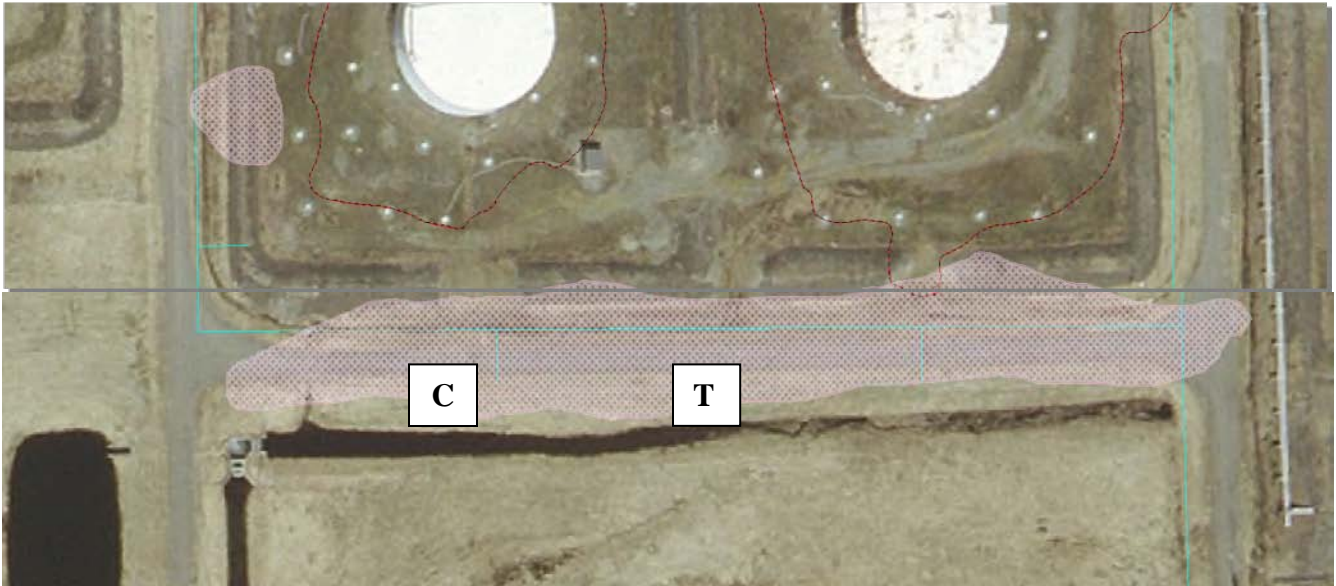
1. Two locations were determined that had similar contamination characteristic from the 2009 Test Pit Delineation Activities Report at the Fuel Tank Farm Site prepared in April 2010 by URS Group Inc. The two locations are TP-25 as the Control Plot and TP-28 as the Treatment Plot (Locations identified below on the aerial photo as C for the control and T for the treatment area). The test plots were determined after review of the above mentioned report.

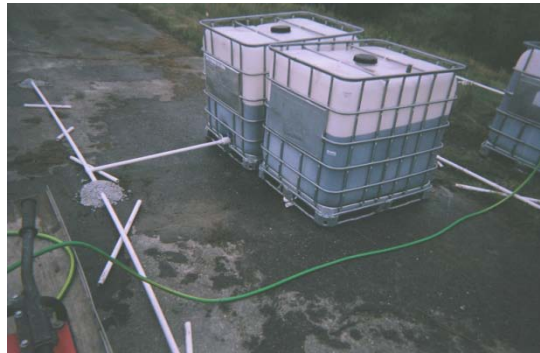
5. For the purpose of the trial it was determined that 3 Tier's Soil Rx would be used to remediate the Treatment location. Soil Rx is a triple-action hydrocarbon remediation product that must be diluted 10 to 1 before application. The recommended application rate for the product is one diluted gallon of Soil Rx per cubic foot of material. The original calculations for the trial estimated approximately 750 cubic yards which required 750 gallons of diluted material to treat. It was decided that three totes would be connected to three holes each on the treatment plot and received 25 gallons of Soil Rx concentrate and 250 gallons of water per tote to feed the three holes. All products were mixed to the previously mentioned solution and each tote was connected to the PVC pipe connected to three boring holes. Each boring hole was plugged and the product was released into the holes and feed using simple gravity. Each tote required approximately 2 hours for all 275 gallons of material to be accepted by the three holes. The control site received 825 gallons of water (Single 275-gallon tote filled three times) to match the liquid addition on the Treatment Plot.

**Product being applied on October 4, 2010**

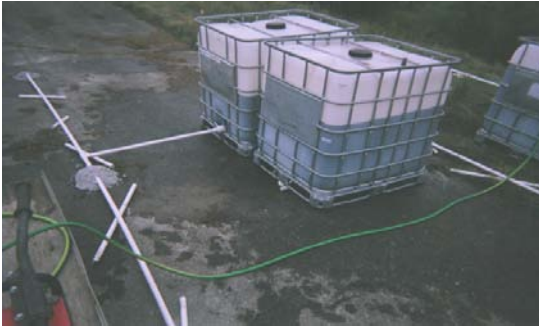
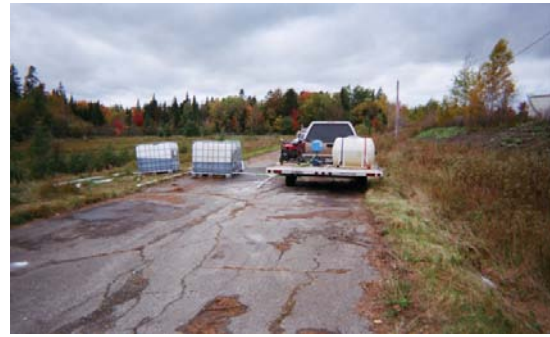
3. As you can see from the photos below, all treatment equipment remains connected and was re-used for the spring treatment. Once the process is completed, all tubing and tanks will be removed and relocated to another treatment site or will be taken for recycling. No additional equipment was needed other than to supply water for the appropriate dilutions.

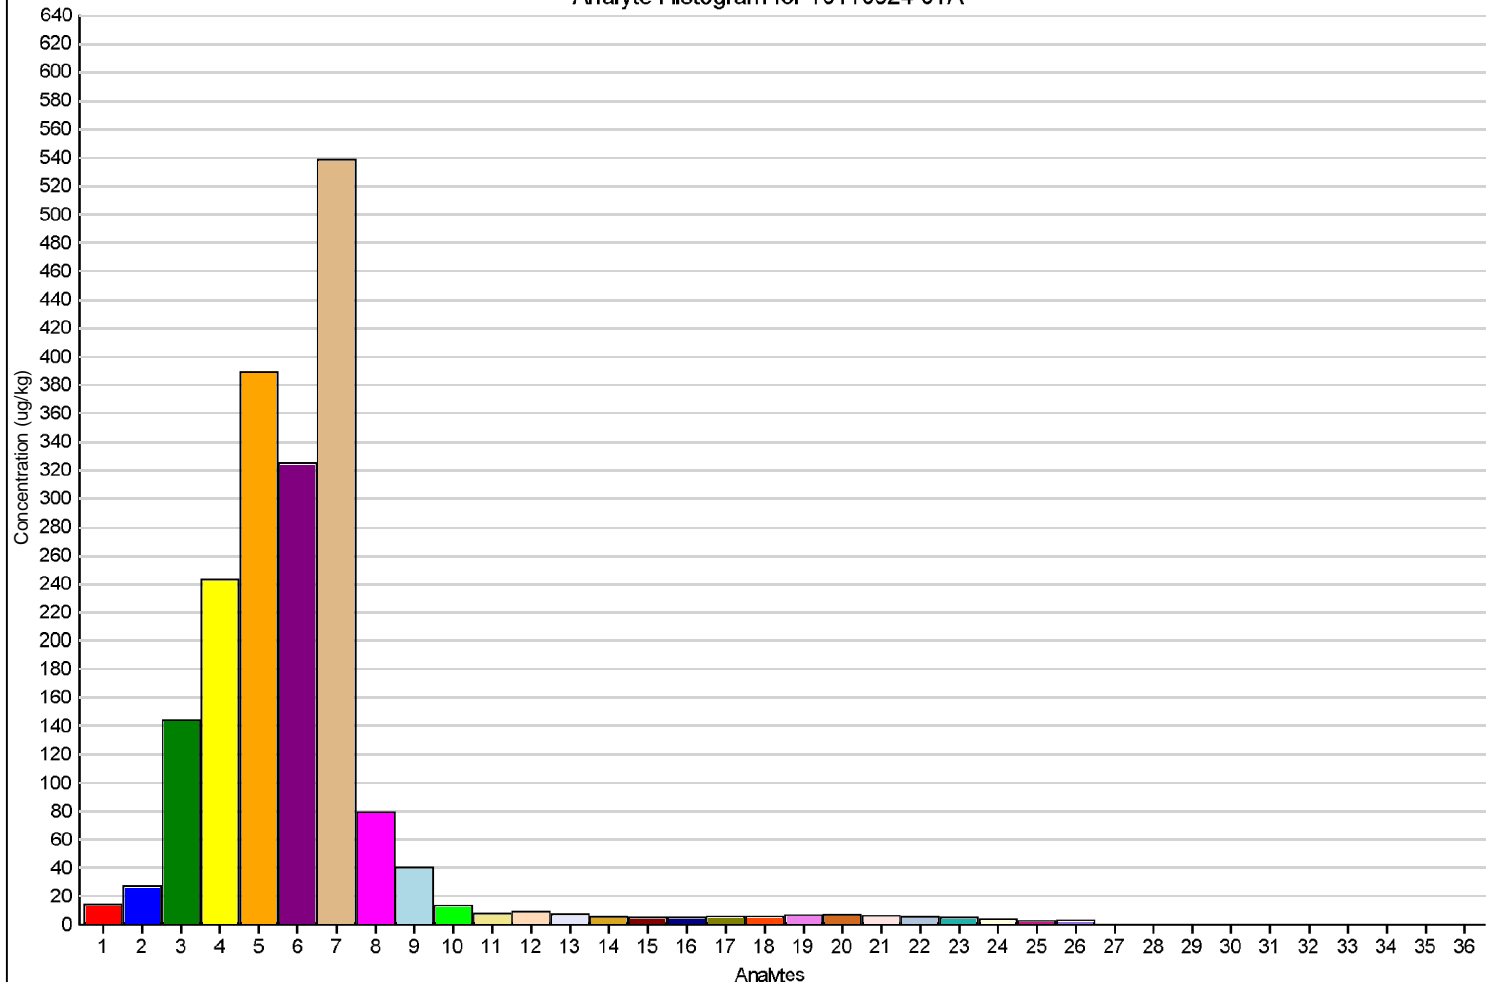
Analyte Histogram for 10110524-01A

10110524-01

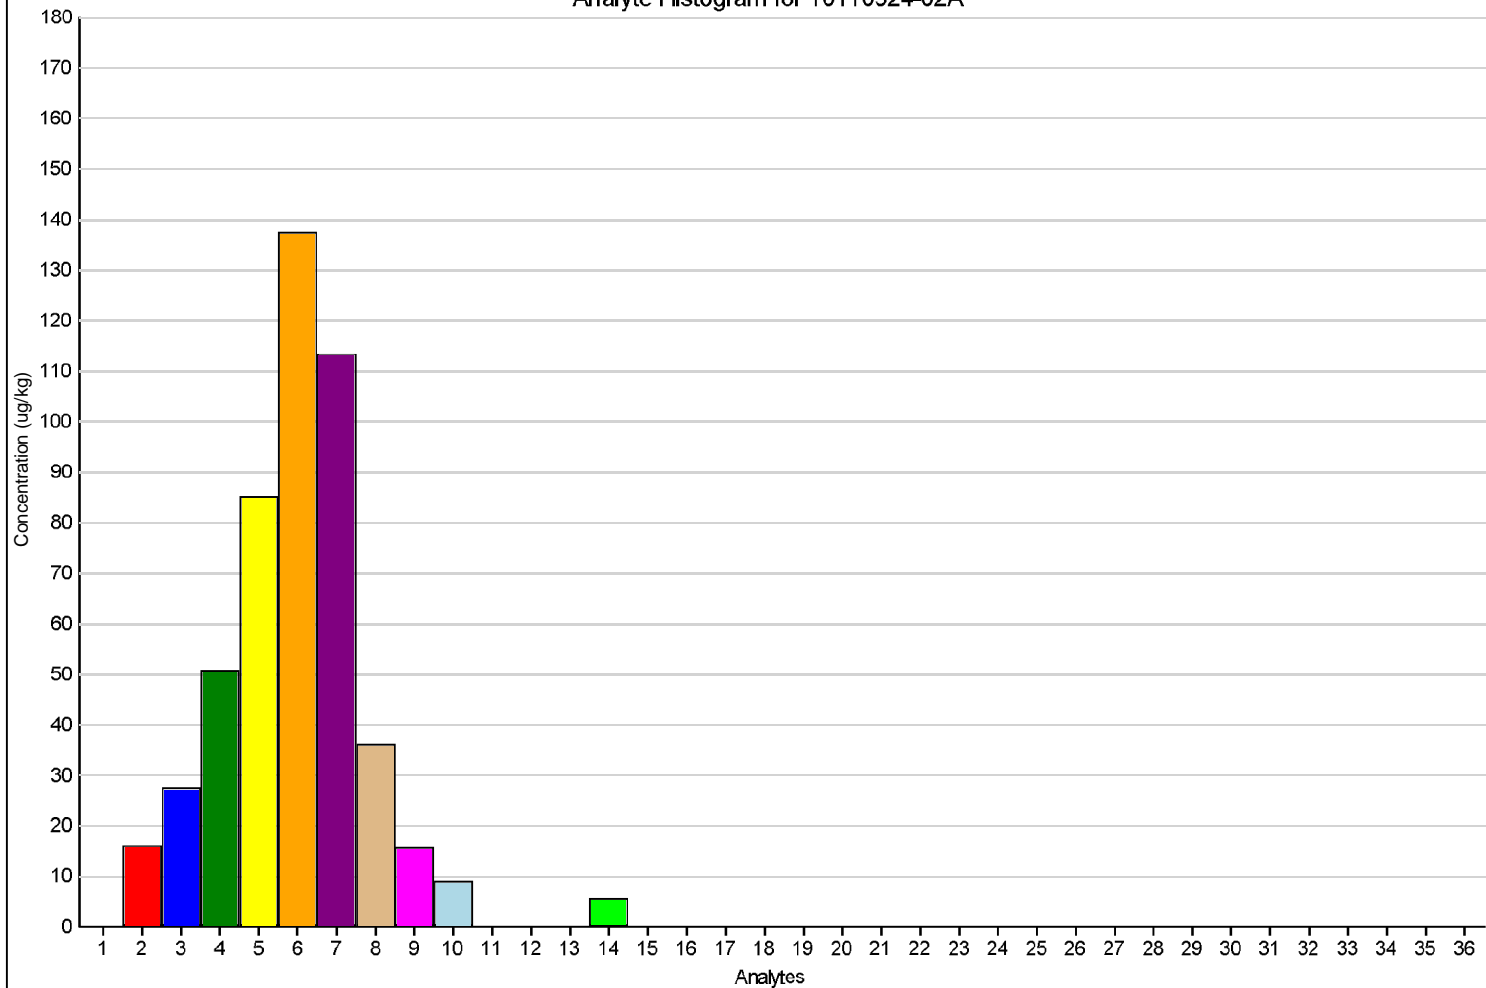
Analyte Histogram for 10110524-02A

10110524-02

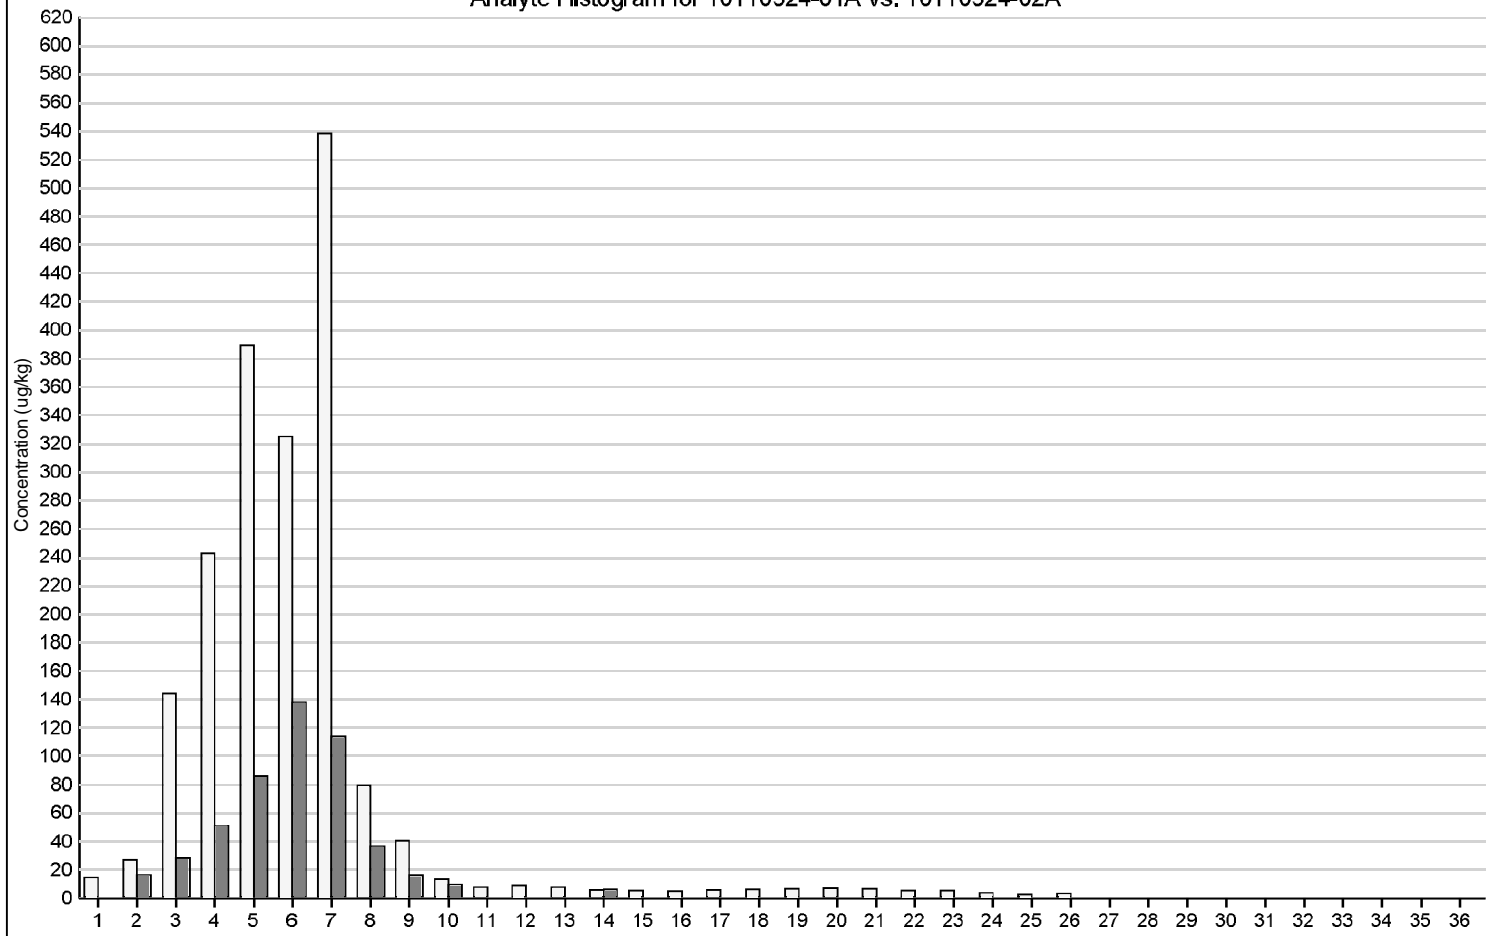
Analyte Histogram for 10110524-01A vs. 10110524-02A

10110524-01 vs 10110524-02
